INDESIT company

Model type:
MB40D2NFBSSP

Commercial code:
F029784

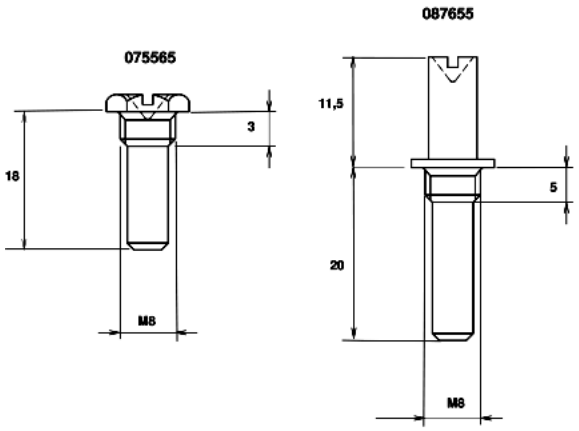
NT007600

From the month of February 2002 (reg. No. 20207.0001) the Melano production has modified, on the electronic Ariston-2001 combinations with the display, the pivot of the hinge because the latter interfered with the wiring, which is lodged in the superior hinge, causing the breakage of the internal filament. Consequently, when it is necessary to substitute the wiring (081844) on the pre-modified models it will be also be necessary to change the pivot of the superior hinge with the new (see figure NT007500). When reassembling the wiring (081844) pay attention that it does not get trodden by the hinge and that it will be positioned around the pivot leaving it soft and not rigid (see figure NT007600).

087655 - SUPERIOR PIVOT HINGE M8X5 (H=20+11,5)

075565 - SUPERIOR PIVOT HINGE M8X3 (18+2,5)

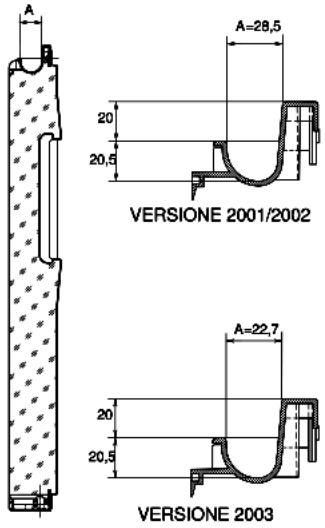
In March 2003 the Melano factory started using freezer doors with modified handle on the Ariston Opera-60 combined fridge-freezers (models MB-MBA-MBAA), in order to eliminate the problem of condensation.
The grip width has been reduced (from 28.5 to 22.7 mm) on these doors, as indicated by the dimension (A) in the figure (N1030059FIG1).
These freezer doors are already available as replacements and a coloured label on the packing distinguishes them from the previous ones. This will be done until stocks of premodification doors run out.
The codes of the freezer doors have not been changed:

In April / May 2003, production standardised the use of the inner door on all these doors, increasing the insulation efficiency by approx. 3%.
The door C00089881 offers approx. 10% more insulation than the door C00081997.

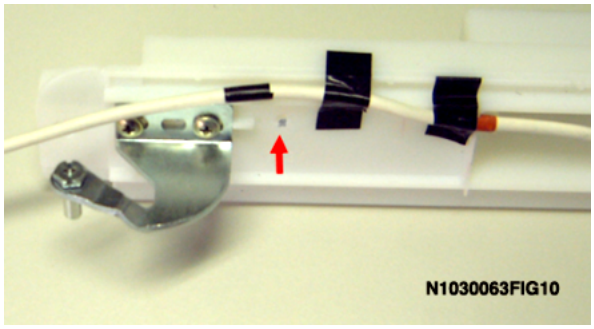
In October 2003 (serial no. 31028.0001) the Melano factory replaced the upper plastic hinge assembly on the Opera-60 fridge-freezers with display, in order to improve the fridge door support and prevent the cable connecting the two cards (power and display) from being damaged.
The new assembly provides for use of the upper hinge, chromed, with relative pin, and modified hinge cover (see fig.1-2).
The hinge assembly is reversible by rotating the single parts 180° and then refitting the pin (see fig.3).
Another two other tape reference marks (now three) have been placed on the card connection cable for correct installation on the panel base and fridge door in order to have the right flexibility during rotation. When the door is open the cable must never be strained.
The reference marks on the cable refer to right hand opening (see fig.4):
-Reference mark (A) indicates which end must be connected to the panel power card.

081644 - UPPER HINGE(M8) RH-LH CHROMED
075565 - UPPER HINGE PIN M8X3 (18+2.5)
097861 - UPPER HINGE COVER RH-LH ALUMINIUM
097862 - UPPER HINGE COVER RH-LH WHITE

097872 - PANEL/DISPLAY WIRING (3-MARKS)

081846 - UPPER HINGE (M8) RH WHITE (WIRING)
081847 - UPPER HINGE (M8) LH WHITE (WIRING)
081844 - PANEL WIRING (DISPLAY) KIT
081848 - UPPER HINGE COVER WHITE
082013 - UPPER HINGE COVER ALUMINIUM-METAL

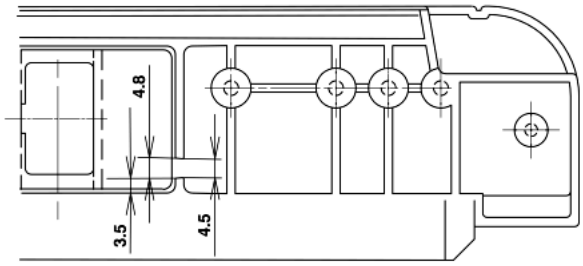
LATO DX / SIDE RH / COTE DROITE / SEITE RECHTS
LADO DERECHA / LATO DIREITO

On the right hand bottom part of the cabinet panel base (hinge area) there is a slot (4.5/4.8) to be used for correct positioning of the cable (see fig.11-12).
Even the first cable seat on the upper head of the fridge door (hinge area, right side) has been modified, from 6x10 mm to 4x20 mm. This prevents the cable from moving when the door is opened/closed (see fig.13).
The fridge doors for models with display, currently managed as replacements, do not have the modification shown in fig.13; in this case the width of the cable (reference area C) must be increased using more adhesive tape until it is blocked in the first support seat (6x10 mm).

On premodification models, the new hinge assembly can only be used if the panel base is modified (see fig.11-12). On the left side the 5 mm slot is already present; whereas, for the fridge door, the width of the cable must be increased on models with right-hand opening (reference area C) as described above.
If the door opens on the left, proceed as described above (fig.7- 8-9-10).

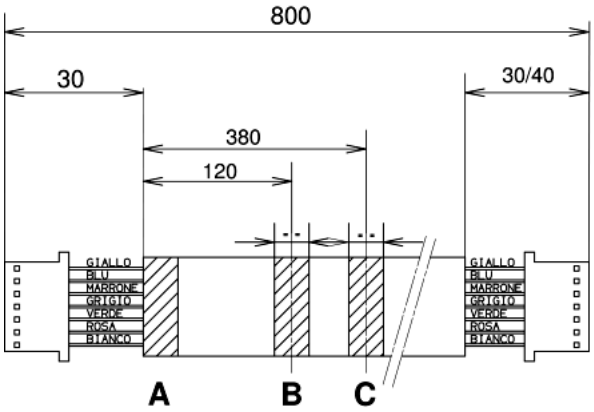
N1030063FIG7

If the door opens on the left, these reference marks on the cable must be modified as shown in fig.7.
(A) has not been changed, whereas (B) has become 120 mm and (C) 380 mm. Colours other than black can be used so as not to confuse them.
Also, reference mark (B) must be fitted in the seat obtained on the panel (see fig.8), whereas the (C) must be fixed in the second tab from the left (see fig.9).
In the left-hand opening version, when tightening the fixing screw make sure the cable is not crushed by the panel. To avoid this, the cable should be fixed with adhesive tape to the vertical and horizontal ribbing, so that it passes inside the groove, thus avoiding the hole (see fig.10).

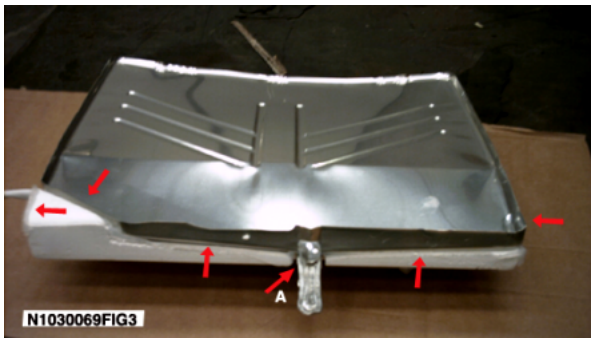
On Ariston and Indesit Opera60 Total No Frost fridge- freezers produced before June 2003, the freezer separator drip hole may be obstructed due to ice build-up.

The problem has been solved by fitting a double filament resistance at the end part, which can be seen by removing the rubber protection. (see fig. 1). The resistance is glued to the drip (see fig. 2).
Freezer separator Sat code 094485, complete with modified resistance, is managed as a replacement to solve the problem on products in use.

If the 40W resistance needs replacing it will be necessary to restore the sealing, located in the hole area, using silicone (see fig3 - ref A).
Also, to protect the separator from possible water penetration, silicone is used to protect the drip with polystyrene insulation at the back, and also the right corner, relevant to the wiring outlet is protected with silicone in the upper part.

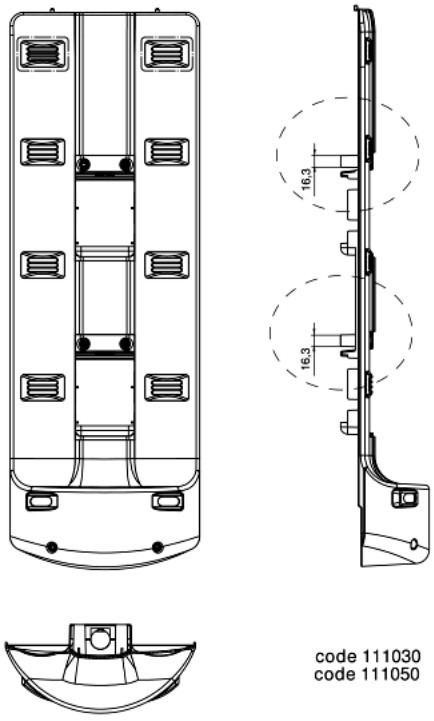
N1030079FIG2

In June 2004 (serial no. 40604.0001), the Melano factory modified the multiflow fixing system to the shell on Ariston and Indesit Opera-60 Total No Frost fridge-freezers.
The inner wall of premodification models featured four square marks (20x20) in the central area for fixing the multiflow cover. The four marks have been eliminated and the wall only features the position for the holes.
Furthermore, the head of the four pins that house the fixing screws on the multiflow cover have been modified. Premodification items ended with an external diameter of 9 mm, whereas the current version has a diameter of 16.3 mm (see figures N1030079FIG1 and FIG2).
The new multiflow cover can be mounted on premodification models but not vice versa, paying attention not to overtighten the screws as the pins may break. If necessary, bush 039567 can be used as stopper.
The multiflow cover is managed as Kit to solve the problem, on products in use, of the formation of condensation on the vegetable basket due to the inflow of cold air from the freezer (see note N1030068).

111030 - 4-way multiflow cover KIT (serial no. 40604.0001)

111050 - 3-way multiflow cover KIT (serial no. 40717.0001).
