INDESIT company

Model type:
MB4033NFIT

Commercial code:
F029467

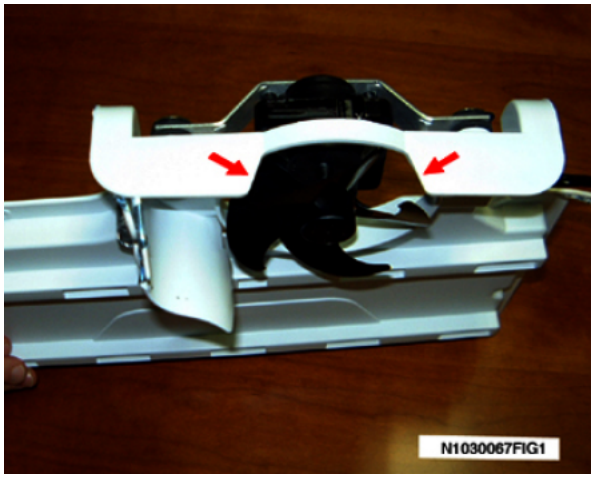
On Ariston and Indesit Opera60 Total No Frost fridge-freezers produced before August 2003, the freezer fan may stop due to ice build-up (stalactites), activating the alarm.
The problem has been solved by emptying the conveyor (chamber separator) in the upper part to give the fan more space (see fig.1).

To solve the problem in products in use, an air conveyor kit (Sat code 094490), which also includes modifications to reduce dispersion air flow, has been introduced since 25/9/2003 (see fig.2) and 06/10/2003 (see fig.3).

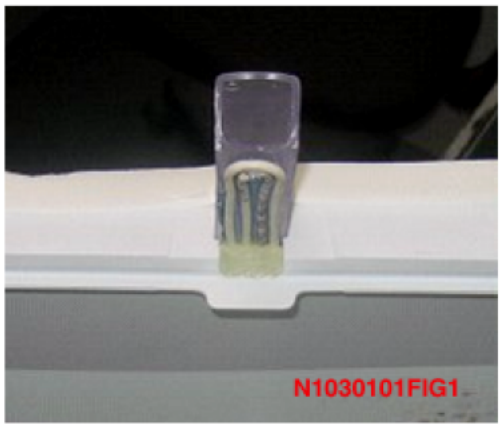
In October 2004, the Melano factory modified the freezer evaporator and return tube on Ariston and Indesit Opera-60 total no frost fridge-freezers, in order to improve the connection.

Now the return tube is straight (outer diameter 6 mm), whereas previously it had a socket end 15 mm long (outer diameter 6.35 mm).
Before the modification, the coil tube on the freezer evaporator (outer diameter 8 mm) was straight, now it has a tapered end section 15 mm long (outer diameter 7.6 / inner 6.2 mm) to insert the return tube.
If the evaporator needs replacing, it will be necessary to connect it with a Lokring connector 7.5/6 NRAL50 (058213) or 7.5/6NRMS00 (058203).

If tightness is lost when the ring is removed, it will be necessary to use connector 8/6 NRAL50 (058214) or 8/6 NRNS00 (042050).

The new freezer evaportor can be fitted on premodification appliances, but once the ring is removed, the 6 mm outer diameter must be restored on the return tube (check that it is long enough to be able to use the pliers to connect the 7.5/6 ring).
