INDESIT company

MB4031NFIT

F029466

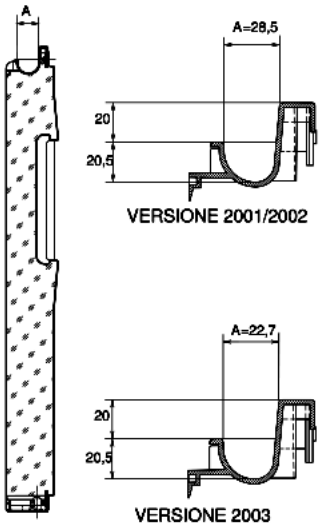
In March 2003 the Melano factory started using freezer doors with modified handle on the Ariston Opera-60 combined fridge-freezers (models MB-MBA-MBAA), in order to eliminate the problem of condensation.
The grip width has been reduced (from 28.5 to 22.7 mm) on these doors, as indicated by the dimension (A) in the figure (N1030059FIG1).
These freezer doors are already available as replacements and a coloured label on the packing distinguishes them from the previous ones. This will be done until stocks of premodification doors run out.
The codes of the freezer doors have not been changed:
