INDESIT company

Model type:
MB40D2NFBSSP

Commercial code:
F029784

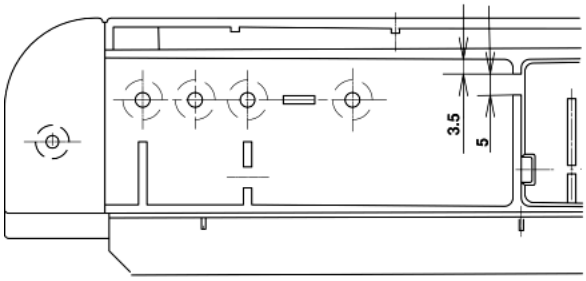
N1030063FIG12

On the right hand bottom part of the cabinet panel base (hinge area) there is a slot (4.5/4.8) to be used for correct positioning of the cable (see fig.11-12).
Even the first cable seat on the upper head of the fridge door (hinge area, right side) has been modified, from 6x10 mm to 4x20 mm. This prevents the cable from moving when the door is opened/closed (see fig.13).
The fridge doors for models with display, currently managed as replacements, do not have the modification shown in fig.13; in this case the width of the cable (reference area C) must be increased using more adhesive tape until it is blocked in the first support seat (6x10 mm).

LATO DX / SIDE RH / COTE DROITE / SEITE RECHTS
LADO DERECHA / LATO DIREITO

LATO SX / SIDE LH / COTE GAUCHE / SEITE LINKS
LADO IZQUIERDO / LATO ESQUERDA

On premodification models, the new hinge assembly can only be used if the panel base is modified (see fig.11-12). On the left side the 5 mm slot is already present; whereas, for the fridge door, the width of the cable must be increased on models with right-hand opening (reference area C) as described above.
If the door opens on the left, proceed as described above (fig.7- 8-9-10).

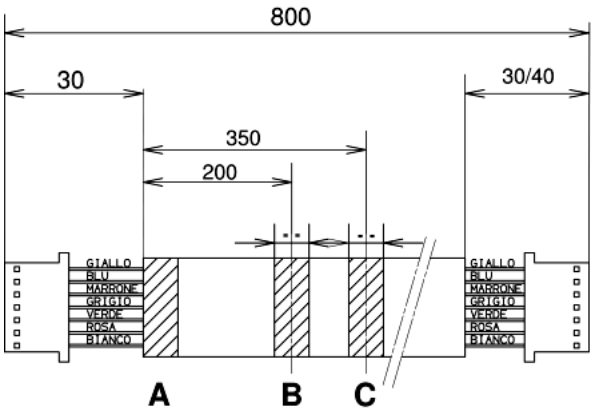
N1030063FIG7

If the door opens on the left, these reference marks on the cable must be modified as shown in fig.7.
(A) has not been changed, whereas (B) has become 120 mm and (C) 380 mm. Colours other than black can be used so as not to confuse them.
Also, reference mark (B) must be fitted in the seat obtained on the panel (see fig.8), whereas the (C) must be fixed in the second tab from the left (see fig.9).
In the left-hand opening version, when tightening the fixing screw make sure the cable is not crushed by the panel. To avoid this, the cable should be fixed with adhesive tape to the vertical and horizontal ribbing, so that it passes inside the groove, thus avoiding the hole (see fig.10).

VERSIONE APERTURA DX
DOOR OPENING RH
OUVERTURE PORTE DROITE
TUEROEFFNER RECHTS
ABERTURA PUERTA DERECHA
VERSIONE APERTURA DIREITA

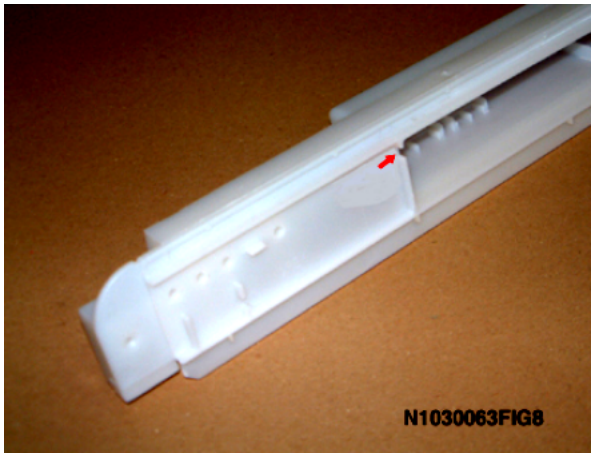
VERSIONE APERTURA SX
DOOR OPENING LH
OUVERTURE PORTE GAUCHE
TUEROEFFNER LINKS
OBERTURA PUERTA IZQUIRDA
VERSIONE APERTURA ESQUERDO

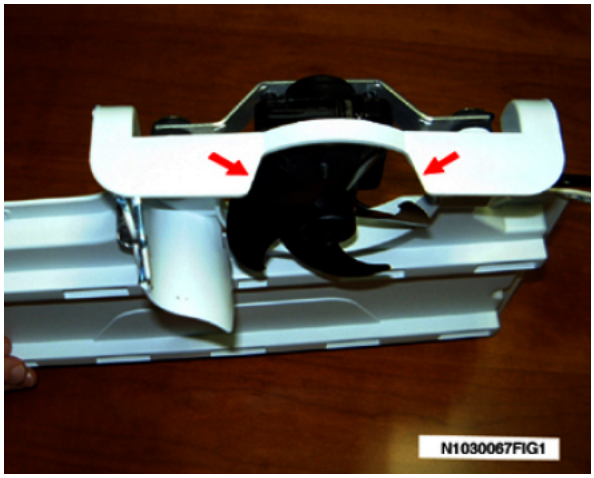
To solve the problem in products in use, an air conveyor kit (Sat code 094490), which also includes modifications to reduce dispersion air flow, has been introduced since 25/9/2003 (see fig.2) and 06/10/2003 (see fig.3).
