INDESIT company

Model type:
B34FNFSP

Commercial code:
F028909

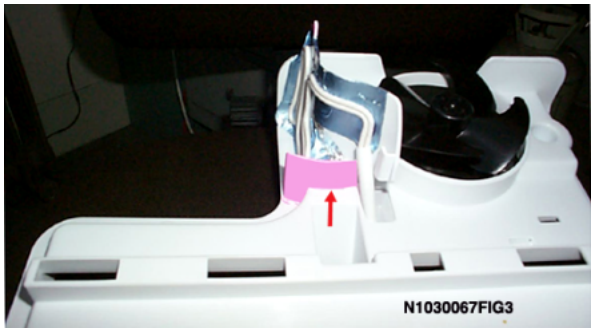
n1030067: Noisy freezer compartment fan in Ariston and Indesit Opera-60 total no-frost fri

On Ariston and Indesit Opera60 Total No Frost fridge-freezers produced before August 2003, the freezer fan may stop due to ice build-up (stalactites), activating the alarm.
The problem has been solved by emptying the conveyor (chamber separator) in the upper part to give the fan more space (see fig.1).

To solve the problem in products in use, an air conveyor kit (Sat code 094490), which also includes modifications to reduce dispersion air flow, has been introduced since 25/9/2003 (see fig.2) and 06/10/2003 (see fig.3).

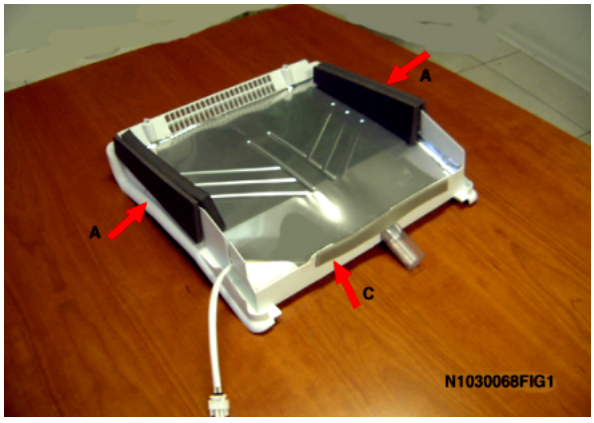
n1030068: Low fridge compartment temperatures in Ariston and Indesit Opera-60 Total No Fro

In Ariston and Indesit Opera-60 Total No Frost fridge-freezers produced before June 2003, there may be a lowering of the fridge compartment temperature in the crisper area (with freezing of food) due to the backflow of cold air from the freezer.
This problem generally occurs when the "super freezer 24 or 48 hours" function is set.
The problem has been solved as follows:

3) The two side sponges on the freezer separator have been lengthened (see fig1-ref. A) and another has been fitted at the back, in the outlet hole area (see fig.1-ref C). Kit 097661 is managed to solve the problem on products in use. This kit includes a double filament resistance (see note N1030069).

4) The air conveyor has been modified to improve air circulation (see N1030067 fig. 2-3). Kit 094490 is managed as a spare part to solve the problem on products in use

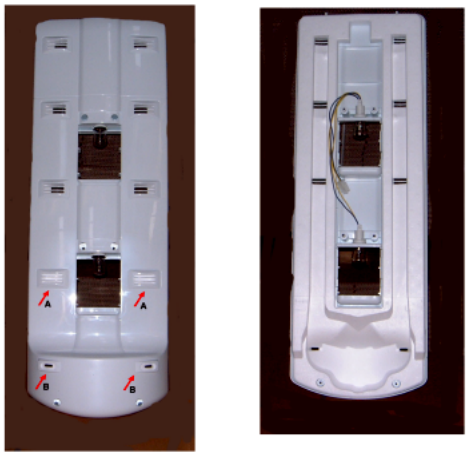
KIT 094675 N1030068FIG3

2) The lower vents on the multiflow have been closed from the inside (see fig.3/4-ref.A) and the outlet of those located in the curved area has been reduced (see fig3/4- ref.B). To solve the problem on products in use there are two spare part kits: 094675 for the version with three outlets, and 094737 for that with four.
