INDESIT company

Model type:
IDC73EU

Commercial code:
F066185

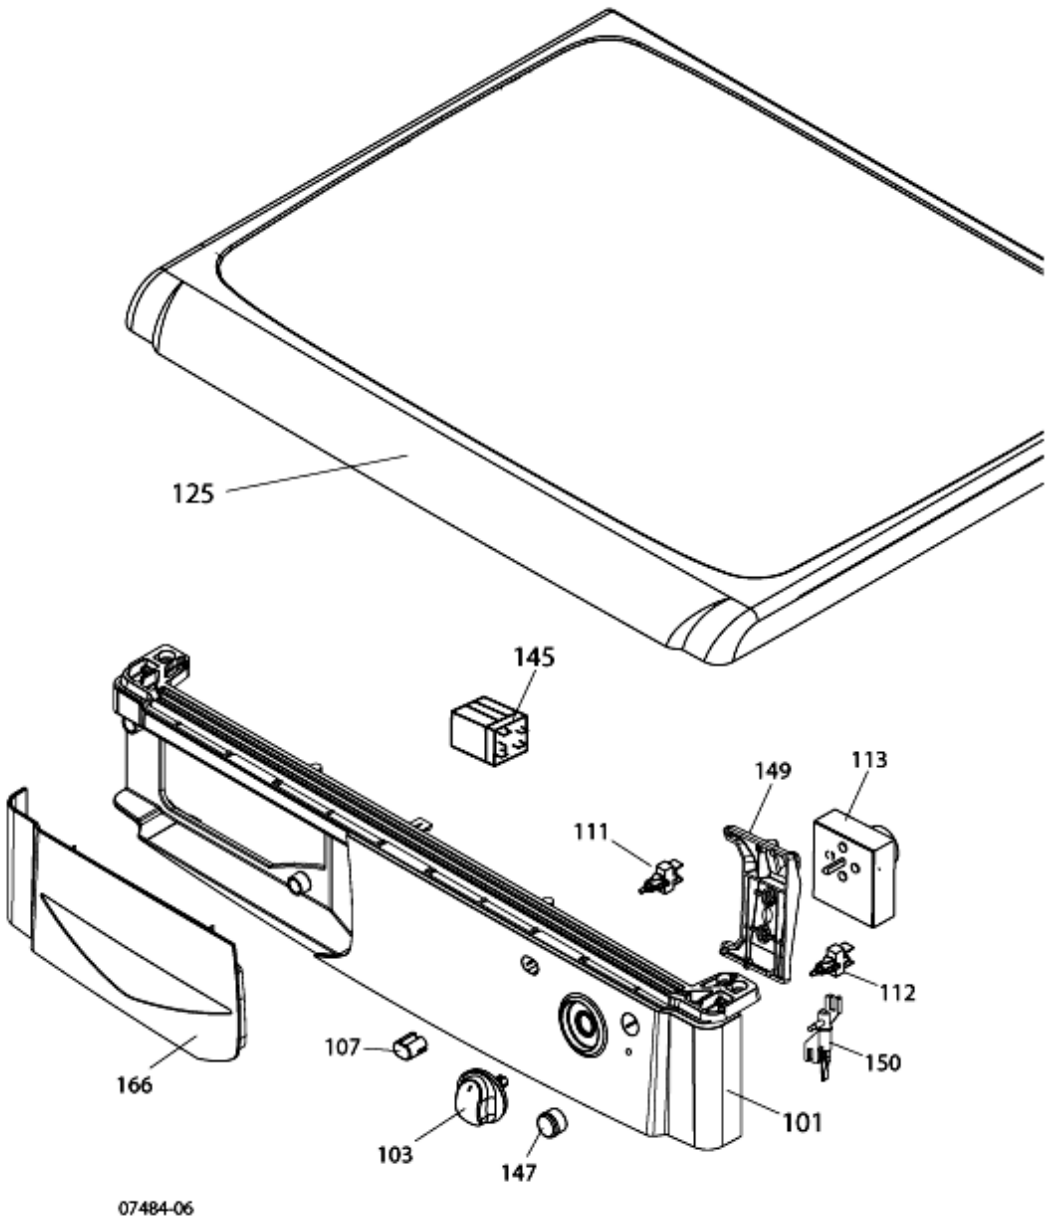
07427-20 Exploded views

n4411j00: PATTERN DRUM INTRODUCED

FROM OCTOBER 2011 A PATTERN DRUM HAS BEEN USED IN PRODUCTION.
THE PATTERN DRUM IS INTERCHANGABLE WITH THE PREVIOUS PLAIN DRUM.
ONCE STOCKS OF THE PLAIN DRUM ARE EXHAUSTED.
THE PATTERN DRUM WILL BE THE SERVICE SPARE.

NOTE
TWO PLAIN DRUMS WERE USED IN PRODUCTION.
THE DRUM SHAFT CAN ONLY BE REPLACED IF THE ORIGINAL DRUM TO SHAFT FIXING IS SCREWED. IF THE DRUM SHAFT IS RIVETED TO THE DRUM, THE COMPLETE DRUM HAS TO BE REPLACED.

n4413j00: BREAKING BELTS

To overcome the issue of breaking belts the 6 Rib belt has been replaced by the 8 rib belt C00300793

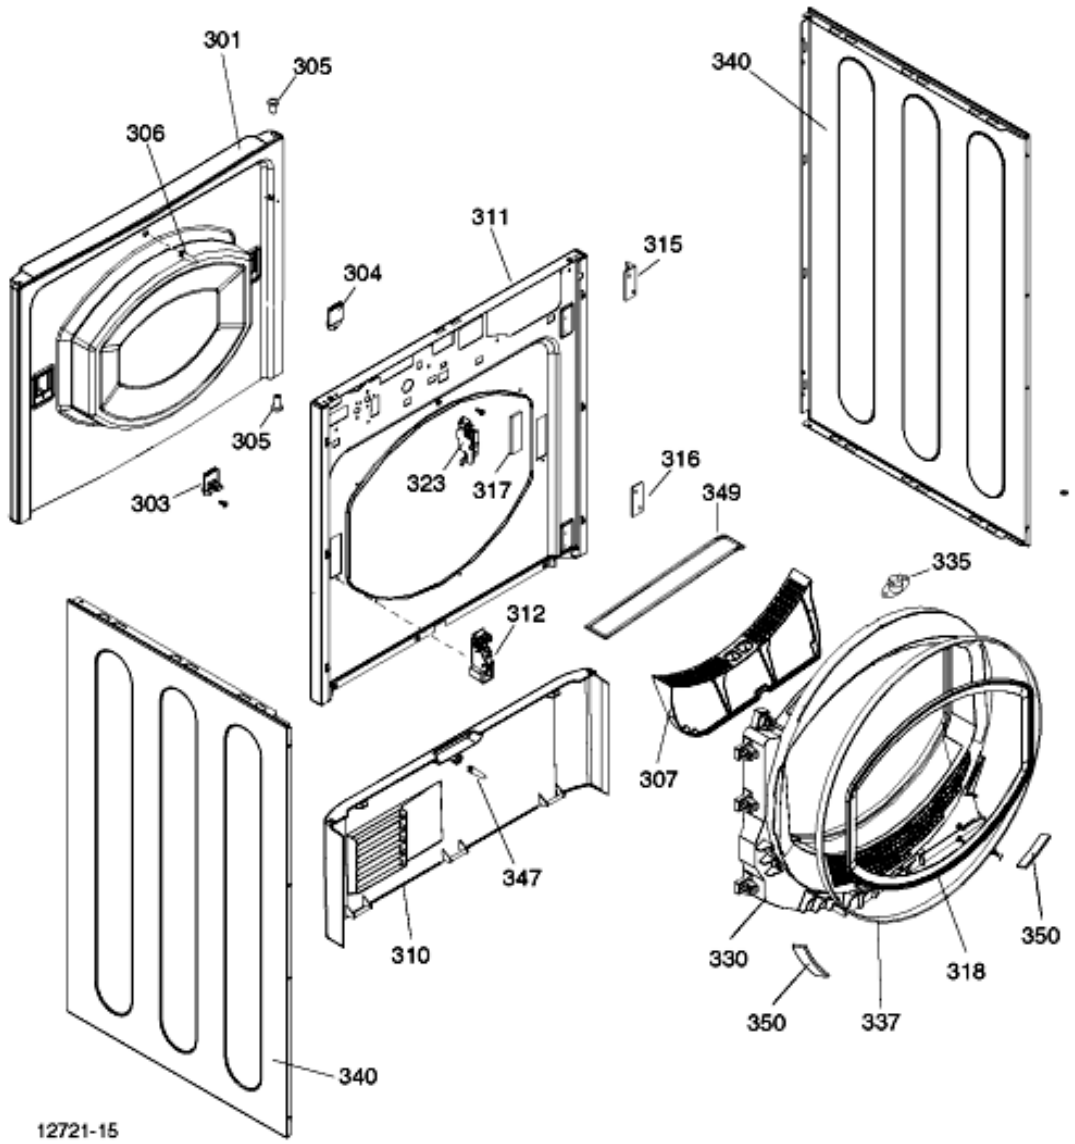
07484-06 Exploded views

n4411i00: CONDENSER REVERSING TIMERS

2 TIMERS HAVE BEEN USED IN PRODUCTION. INVENSYS AND BITRON (ELBI).
CHECK THE TIMER FITTED TO THE MACHINE BEFORE ORDERING.

THE TIMERS ARE INTERCHANGEABLE, BUT THE TIMER CONECTIONS ARE LABELLED DIFFERENTLY.
THE ALTERNATE WIRING CONNECTIONS ARE SHOWN IN THE WIRING DIAGRAM FOUND IN THE SERVICE MANUAL OR WIRING DIAGRAM.

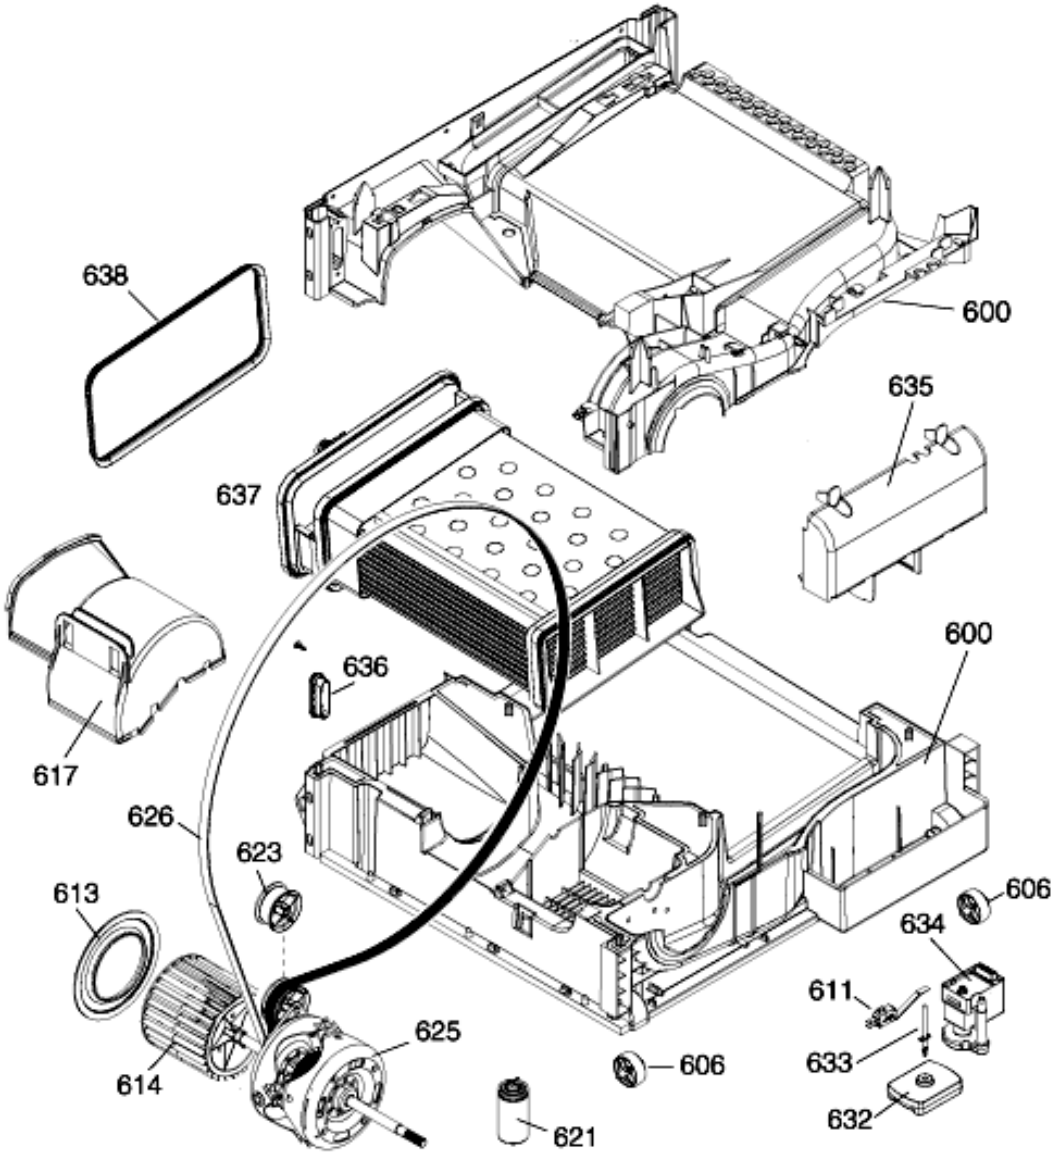
12721-15 Exploded views

n4411g07: CONDENSER FRONT AIR DUCT COLOUR CHANGE

FROM JUNE 2011 THE FRONT AIR DUCT FITTED TO CONDENSER TUMBLE DRYERS CHANGED IN PRODUCTION FROM GREY TO WHITE.
SELECTED THE CORRECT PART BY DESCRIPTION IN THE PARTS LIST

n4414b02: DOOR RELAY REPLACED IN PRODUCTION

DURING OCTOBER 2013 THE DOOR RELAY AND ASSOCIATED DOOR SWITCH FITTED TO CERTAIN TUMBLE DRYERS IS NO LONGER USED IN PRODUCTION.
A BITRON DOOR SWITCH/LOCK ASSEMBLY REPLACES THE ORIGINAL DOOR RELAY AND DOOR SWITCH.
NOTE DURING OCTOBER 2013 THE TYPE OF DOOR LOCK WILL HAVE TO BE VISUALLY IDENTIFIED AS BOTH THE ORIGINAL DOOR LOCK AND RELAY AND THE BITRON DOOR SWITCH/LOCK HAVE BEEN USED IN PRODUCTION.
