INDESIT company

Model type:
AVD88EX

Commercial code:
F029991

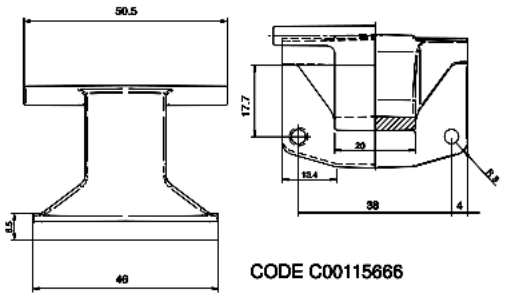
Fig . 001

n1040349: Introduction of 150° Zamac hinge on Ariston 46 models.

From serial no. 50207.0001, all Ariston models produced in the Teverola factory (see table 001 attached) with industrial code (given on the rating plate) starting with 46, have been equipped with a Zamac hinge with 150° opening angle, code C00115666

(see Fig.001).
This modification has involved the introduction of the following items:

Code C00115670 - Complete door EVOII 150° white 27 with standard glass;
Code C00115674 - Complete door EVOII 150° white 27 with long glass;
Code C00115667 - EVOII body for 150° hinge white 27;

The premodified items are not interchangeable separately with the modified ones.

Code C00110133 - Complete door EVOII Standard 180° white 27 standard glass;
Code C00092157 - Complete door EVOII 180° white 27 long glass;
Code C00096193 - EVOII body for 150° hinge white 27;
