INDESIT company

Model type:
WIL105XEX

Commercial code:
F030539

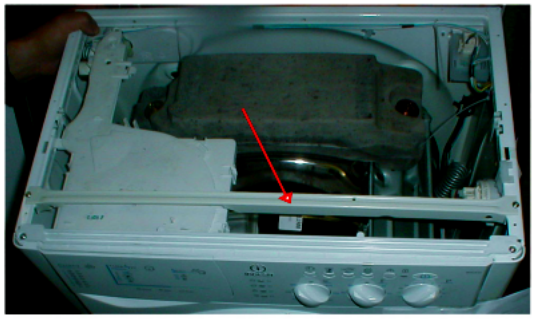
N1040319FIG1

n1040319: Elimination of metal bar on INDESIT cabinets.

From serial no. 40223.0001 Indesit EVOII Washing Machines produced in the Comunanza - Brembate factory have been equipped with a wooden reinforcing strip on the top, whereas the metal bar on the cabinet has been eliminated.

The modified tops have the same Service code as premodification items (096937, 097617, 098440, 099929 and 097806).
When using the new top on a premodification appliance the metal bar (see N1040319FIG1) must be removed, whereas the old top can be used in place of the new one without any modification.
The new top can be used in place of the old one and vice versa; the Service code remains the same.

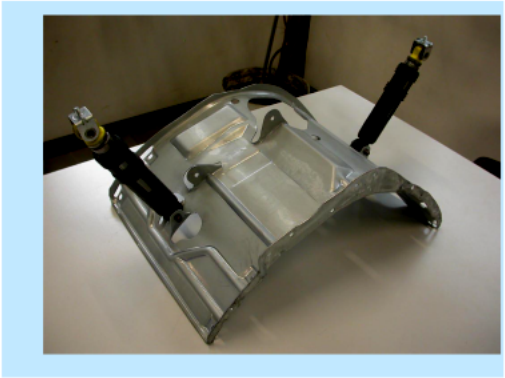
n1040325: New shock absorber fixing system with pin

From serial no. 40427.0001, shock absorbers have been fixed to the tank unit cradle with two 11 mm pins code C00110163 (see fig. 01 and 02 enclosed) in place of the 8 mm screws code 093750 and relevant locking nuts code 030443, on all washing machines and dryers produced in the Comunanza factory.
The items affected by this modification are:
1) The cradles have the same Service code, as they can be used in place of the new ones after widening the shock absorber fixing holes to a diameter of 10 mm.
Code 093848 - Tank unit cradle 46 lt
Code 093878 - Tank unit cradle 40 lt.

To remove the shock absorber from the tank, first extract the pin with a few hammer taps (see fig.03) until it is aligned with the tank bracket and then pull it out with a pair of pliers (see fig. 04).
(To refit the shock absorber use a new pin. Insert the pin until the toroidal edge is aligned with the bracket.)
