INDESIT company

Model type:
AVF109SIT

Commercial code:
F033137

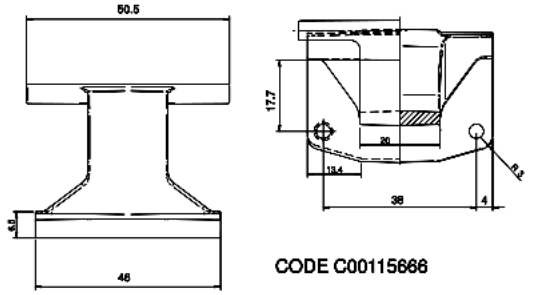
Fig . 001

n1040353: Introduction of 150° Zamac hinge on Ariston models (Comunanza).

From serial no. 50207.0001, all Ariston models produced in the Comunanza factory (see table 001 attached) with industrial code (given on the rating plate) starting with 80, have been equipped with a Zamac hinge with 150° opening angle, code C00115666 (see Fig.001).
This modification has involved the introduction of the following items:

Code C00115670 - Complete door EVOII 150° white 27 with standard glass;
Code C00115674 - Complete door EVOII 150° white 27 with long glass;
Code C00115668 - Complete door EVOII 150° silver with standard glass;
Code C00115673 - Complete door EVOII 150° silver snella standard glass;
Code C00115662 - EVOII body for 150° hinge white 27
Code C00115663 - EVOII body for 150° hinge silver 27
Code C00115664 - Snella EVOII body for 150° hinge white 27
Code C00115665 - Snella EVOII body for 150° hinge silver

The premodified items are not interchangeable separately with the modified ones.
