INDESIT company

Model type:
WISL85PL

Commercial code:
F030562

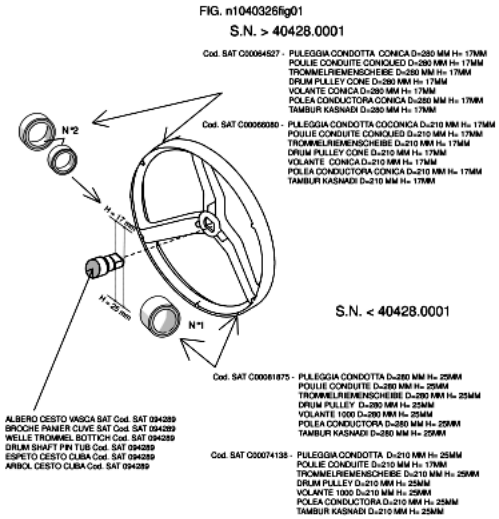
n1040326: Two-bearing mechanism on Slim range washing machines

From serial no. 40428.0001, all Slim range models produced in the Comunanza factory have been equipped with a two-bearing mechanism in place of the single-bearing one.

The tank assembly with the new two-bearing cross has the same Service code as the single-bearing one (C00094289); the latter will be available until stocks run out.
When replacing the tank, make sure that the value H (17 mm or 25 mm) of the basket cross shaft corresponds to the value H of the pulley (see Fig.001).
