INDESIT company

Model type:
AVSD1090SEXV

Commercial code:
F045740

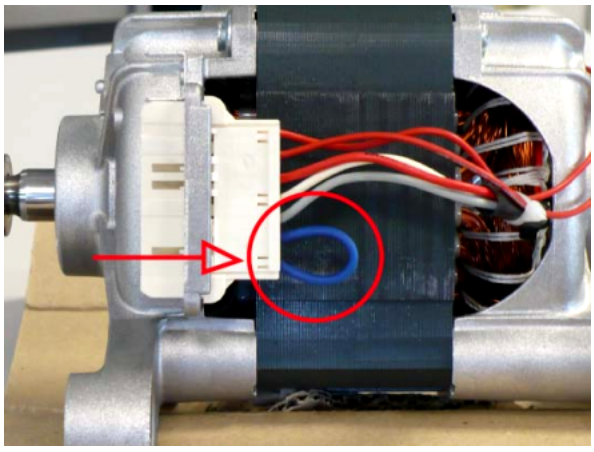
n4008f00: Thermic link wire removed on three-phase motor

Attention!
When you assist the premodification models using the new motor code you MUST use the thermic link wire code C00265838.

In the attached image you can see the fixing of thermic link wire in the motor therminal box.
